Addendum Review of Hartford Civic Center

Hartford Civic Center

Facility Analysis - Evaluation and Comments

June 2, 2006

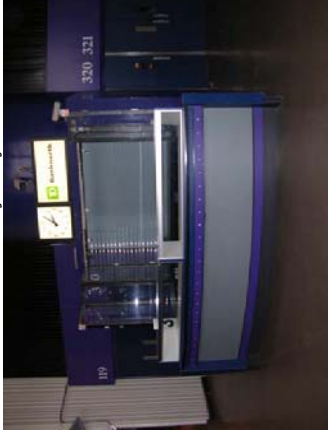
The main entrances for ticketed fan entry are moderately spacious and in good condition. Large kiosks for event merchandise are located directly in front of the entry doors. Because queuing space is limited in front of the concourse concession stands, and because concession sales are typically higher than merchandise sales, we propose that the CDA consider converting these kiosks to concession points of sale that would allow more queuing space. It would present immediate opportunity for fans to purchase concession items upon entry. Careful attention would have to be paid to avoid conflicting with high volume entry traffic

Merchandise kiosk in entry lobby.

prior to events. The additional POS would reduce the amount of queuing in the very narrow concourse concession areas. A smaller concession stand in the concourse could be converted to a memorabilia stand.

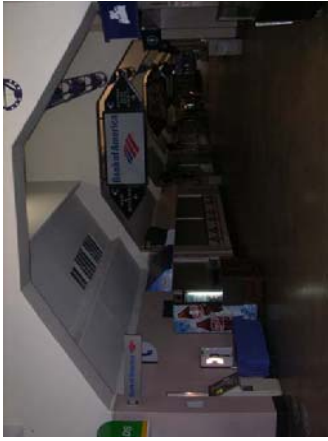
Main concourse:

The existing floor is sealed concrete and is in need of updating. Application of a new concrete coating will serve multiple purposes. First, it will help to improve the light quality in the corridor in concert with the new wall colors. Next, if a seamless, built-up coating were to be installed to a thickness of approximately 3/4", the large quantity of shrinkage cracks would be concealed. Coatings such as Stonhard are relatively cost effective when compared to

more premium coatings such as tile or terrazzo, and are very durable and easily maintained. They are also capable of spanning most concrete control joints and cracks without telegraphing through to the surface.

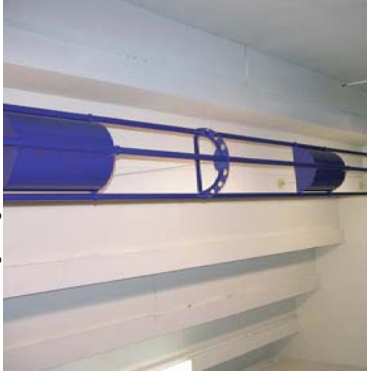
Concourse lighting fixture:

Currently, the main source of lighting in the concourse areas is indirect fluorescent fixtures that reflect light off the bottom of the precast seating bowl above. These fixtures, in combination with lighted sponsorship, concession and way-finding signage provide an adequate and comfortable level of light throughout the concourse areas. We believe the proposed new color scheme for walls and floors is all that is needed to improve concourse lighting.

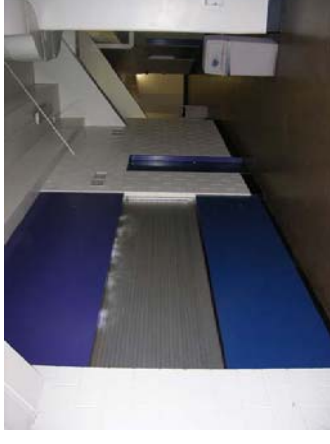
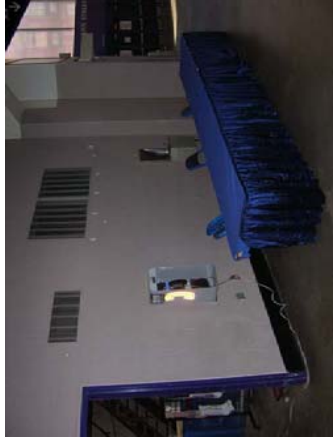
300 level concourse:

The 300 Level Concourses are very narrow with minimal amenities. Due to structural limitations and the limited number of seats served by these concourses, it is not economically feasible to invest in significant capital improvements which might include larger concourses, expanded concession stands and increased number of restrooms. However, additional way-finding and concession signage may be added at minimal cost to improve the overall feel of the spaces. Beyond that, there is little that can be done to increase revenue generated in these areas.
